test report

The fire resistance performance of an uninsulated, fabric curtain roller doorset, in accordance with BS 476: Part 22: 1987, Clause 8.

WF Report No:

161169

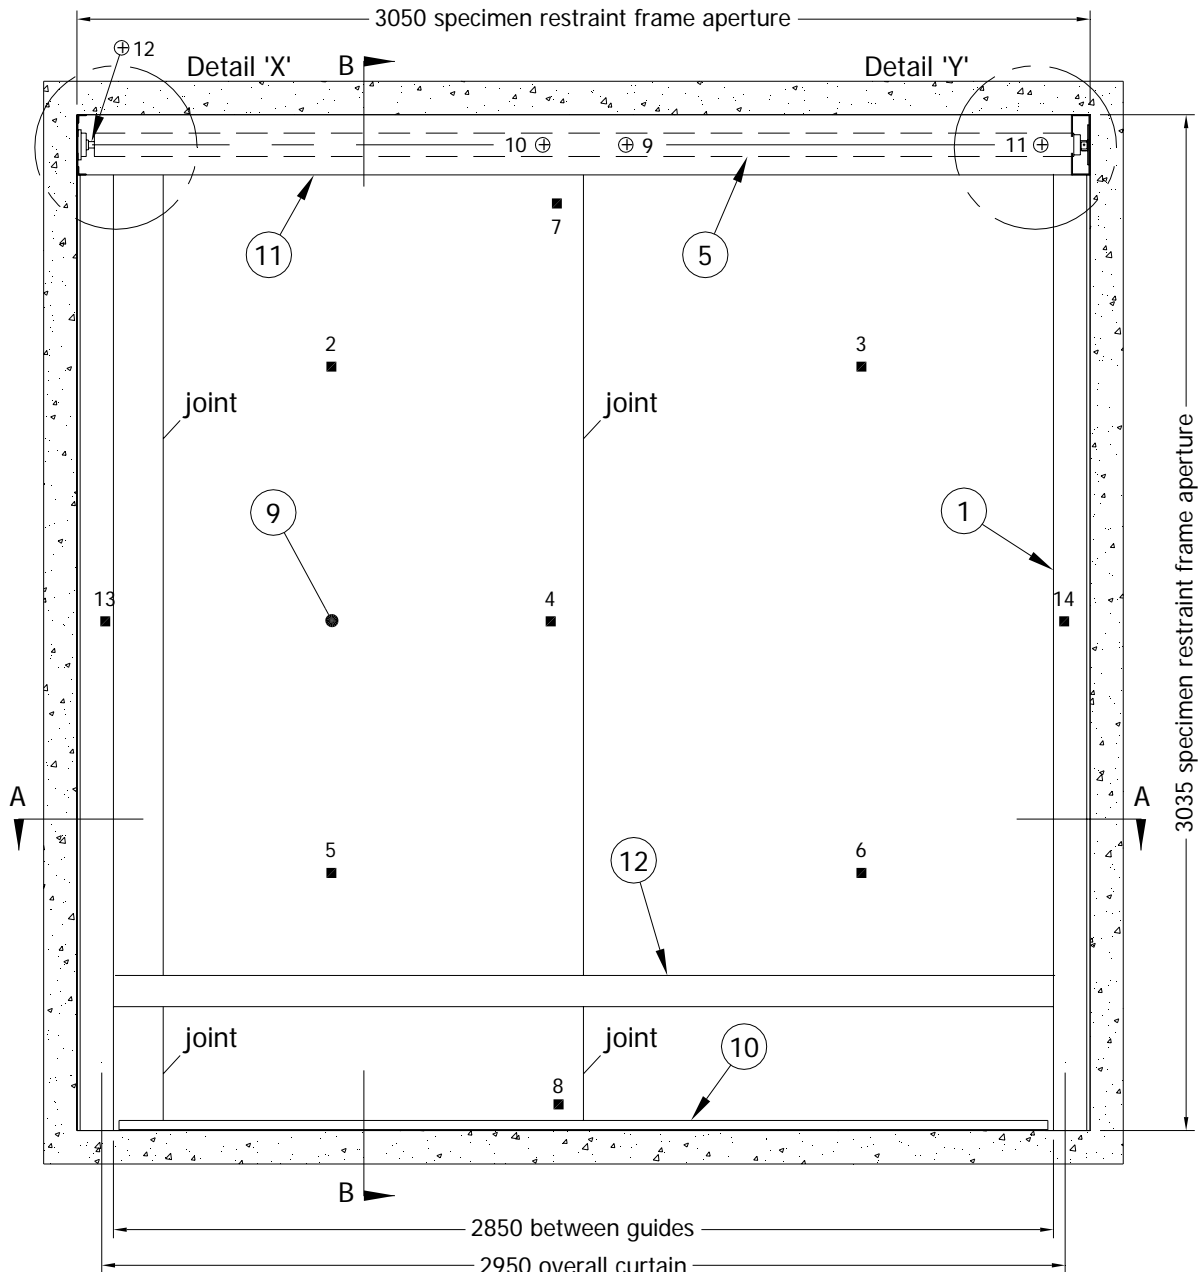
Figure 1- General elevation of test specimen and unexposed face thermocouples

GENERAL ELEVATION OF UNEXPOSED FACE

Positions of thermocouples

- surface mounted thermocouples (Nos. 2 to 8)
- ⊕ mineral insulated thermocouples (Nos. 9 to 14)

Thermocouples 9 to 12	At three positions on the barrel and at one position on the axle. The locations and reference numbers of the various unexposed surface thermocouples are shown in Figure 1.
Roving Thermocouple	A roving thermocouple was available to measure temperatures on the unexposed surface of the specimen at any position which might appear to be hotter than the temperatures indicated by the fixed thermocouples.
Integrity Criteria	Gap gauges were available to evaluate the impermeability of the specimen to hot gases.
Radiometer	A water-cooled foil heat flux meter was used to record the heat radiation from the doorset. The heat flux meter was positioned at a distance of 3674 mm from the unexposed surface of the specimen, so that its angle of view circumscribed the diagonal of the doorset.
Furnace Pressure	After the first five minutes of testing and for the remainder of the test, the furnace atmospheric pressure was controlled so that it complied with the requirements of BS 476: Part 20: 1987, Clause 3.2.2. The calculated pressure differential relative to the laboratory atmosphere at the top of the doorset was 17 (± 2) Pa.

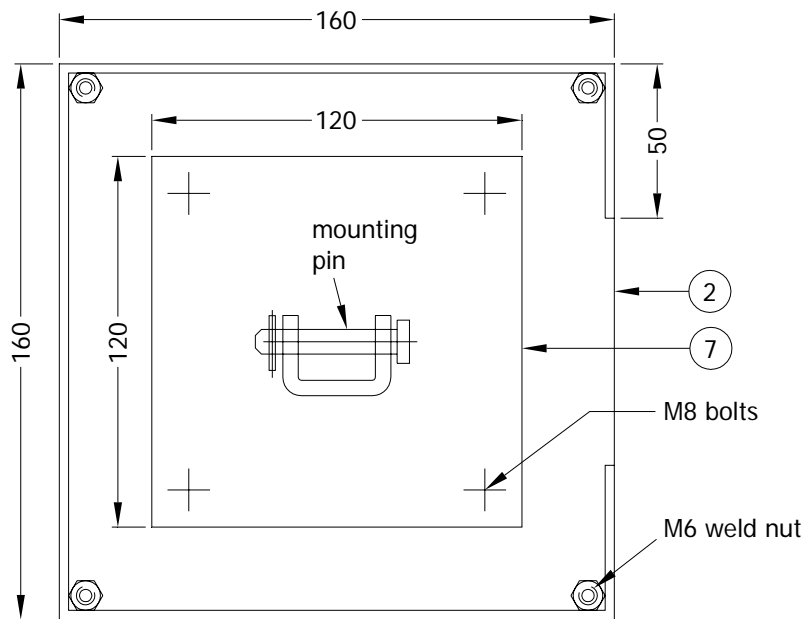
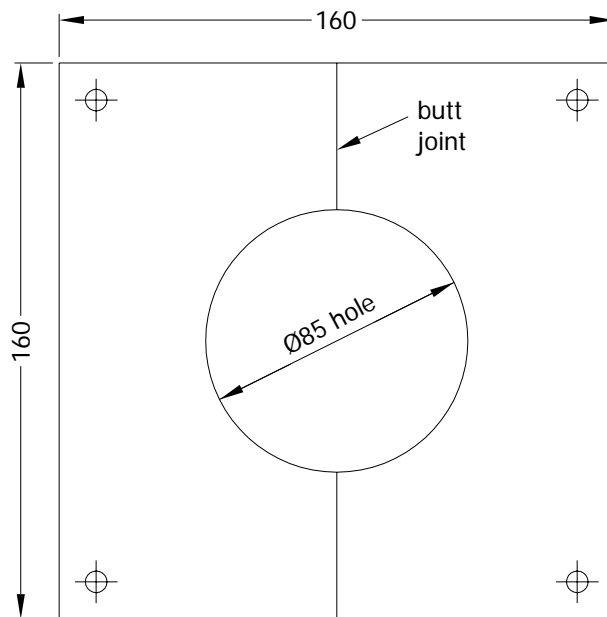
Figure 5 – Details of drive end plates

View on End Plate (item 2)

Barrel Support Plate (item 3)

DETAILS OF DRIVE END PLATES

2. End Plate (motor end)	
Material / type	: Mild steel plate, with 50 mm wide right angle returned ends having 6 mm diameter tapped holes for fixing of the top box
Thickness	: 3 mm
Overall size	: 160 mm x 160 mm
Fixing method	: Bolted to masonry wall with 2 no. anchor bolts 10 mm diameter with steel and nylon washers

3. Head Plate (motor end)	
Material	: Mild steel plate
Thickness	: 3 mm
Overall size	: 160 mm x 160 mm, with an 85 mm diameter central hole.
Fixing method	: The plate is cut vertically in half to enable fitting around barrel. The plate is bolted to the end plate with 4 no. 6 mm diameter weld nuts

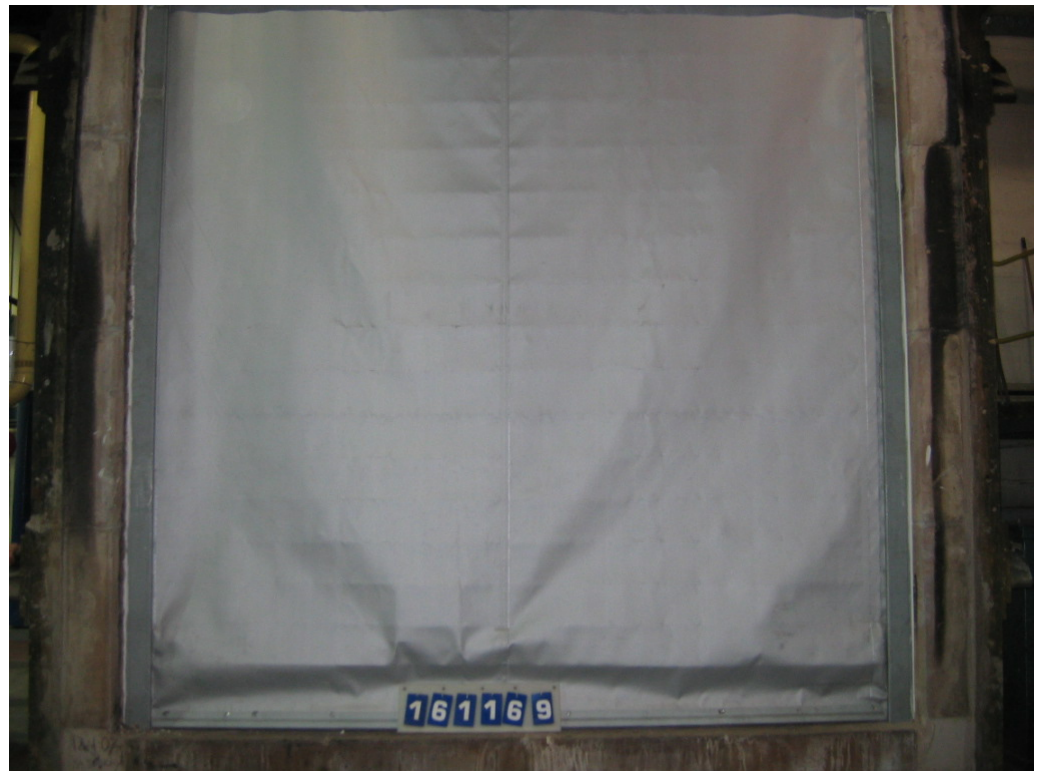
The exposed face of the specimen prior to testing

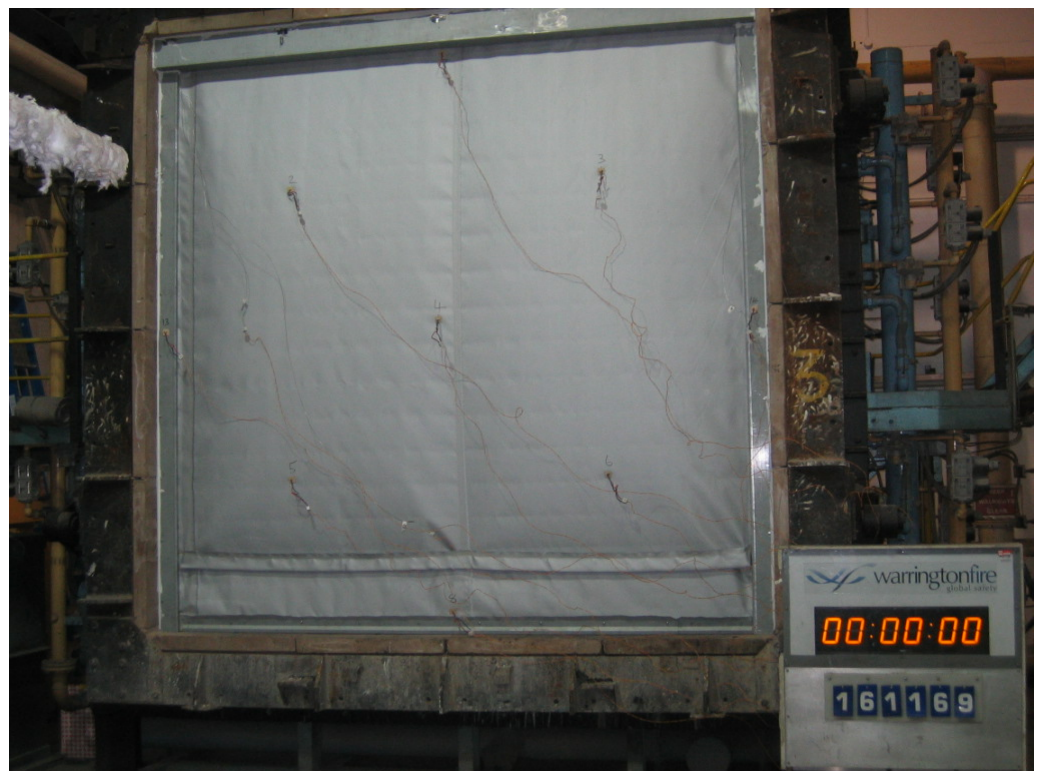
The unexposed face of the specimen prior to testing

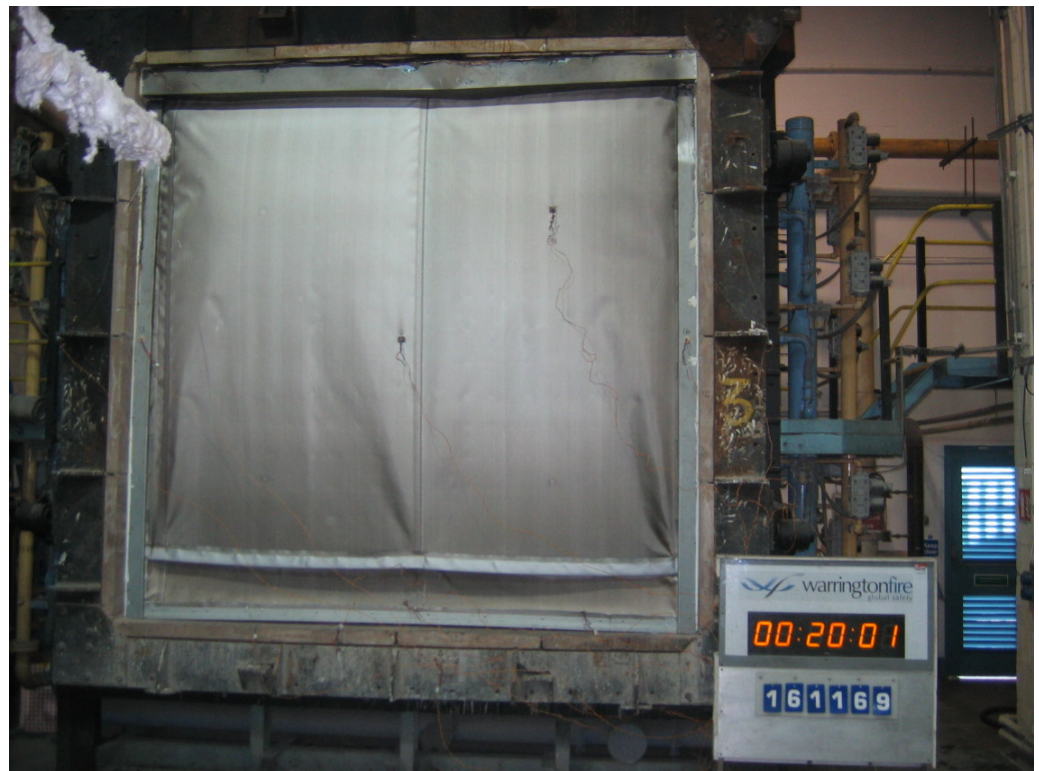
The unexposed face of the specimen after 20 minutes of testing

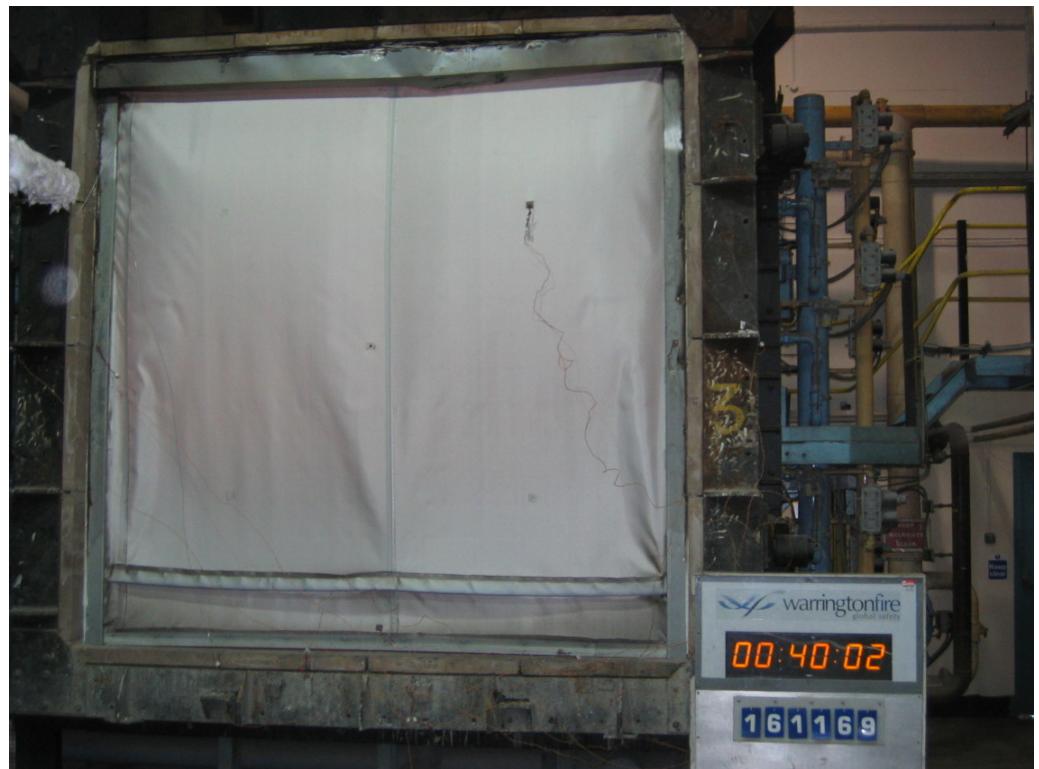
The unexposed face of the specimen after 40 minutes of testing

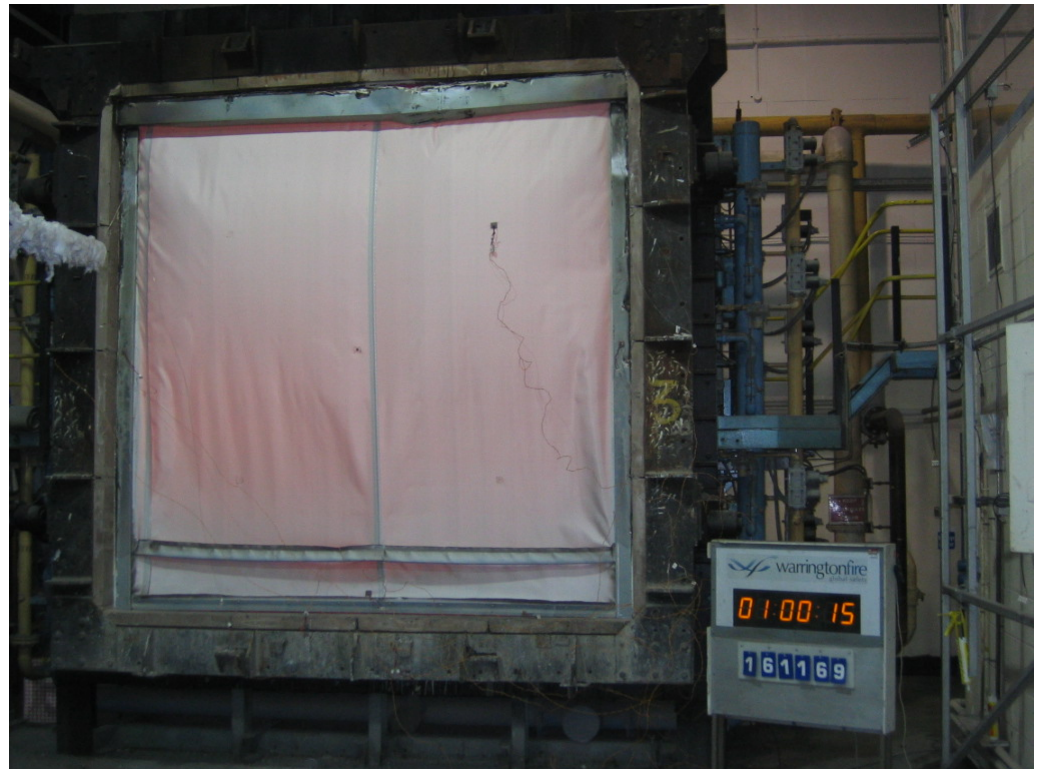
The unexposed face of the specimen after 60 minutes of testing

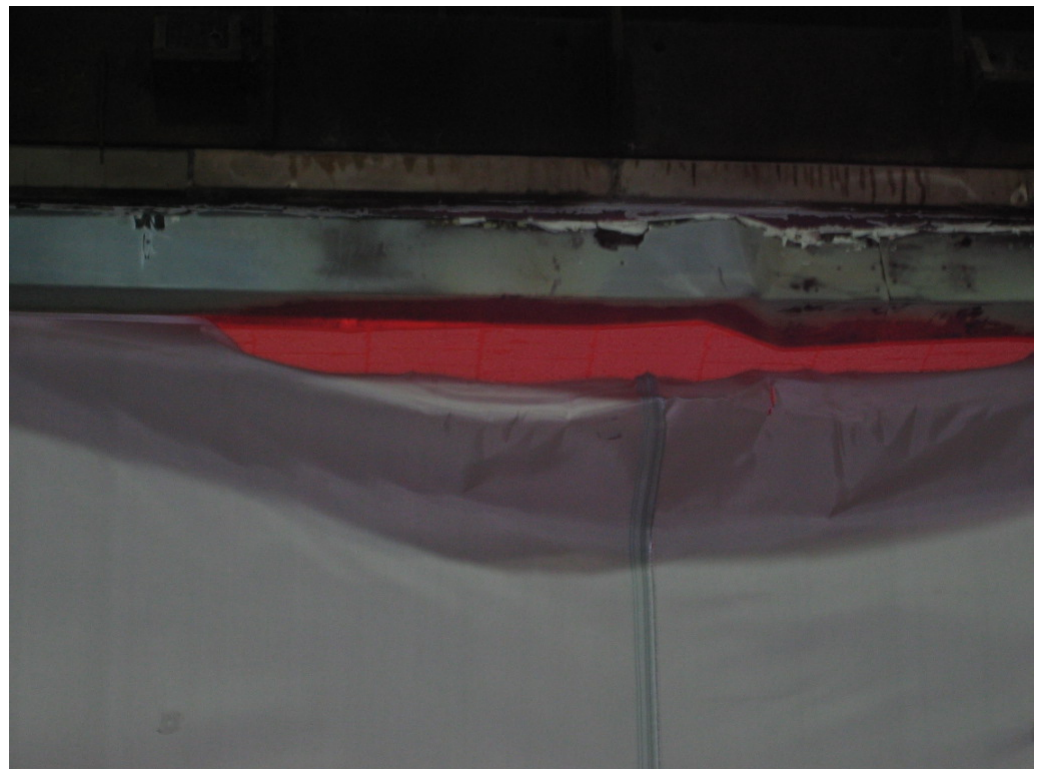
Integrity failure after a duration of 69 minutes

60	00	The specimen continues to satisfy the integrity criterion of the test.
69	00	A hole has formed in the curtain fabric below the head box in excess of 25mm. Integrity failure is deemed to have occurred. The test is discontinued.

It is required that there is no collapse of the specimen, no sustained flaming on the unexposed surface and no loss of impermeability. These requirements were satisfied by the specimen for 69 minutes after which time gap gauge failure occurred.

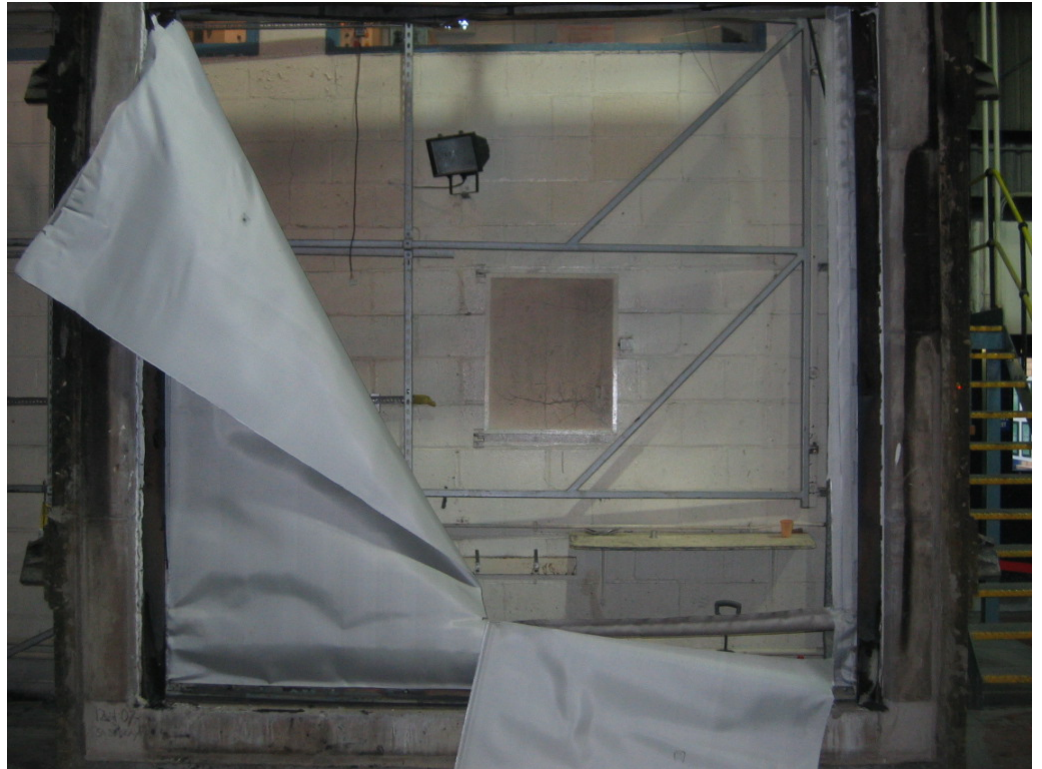
The exposed face
of the specimen
immediately after
testing

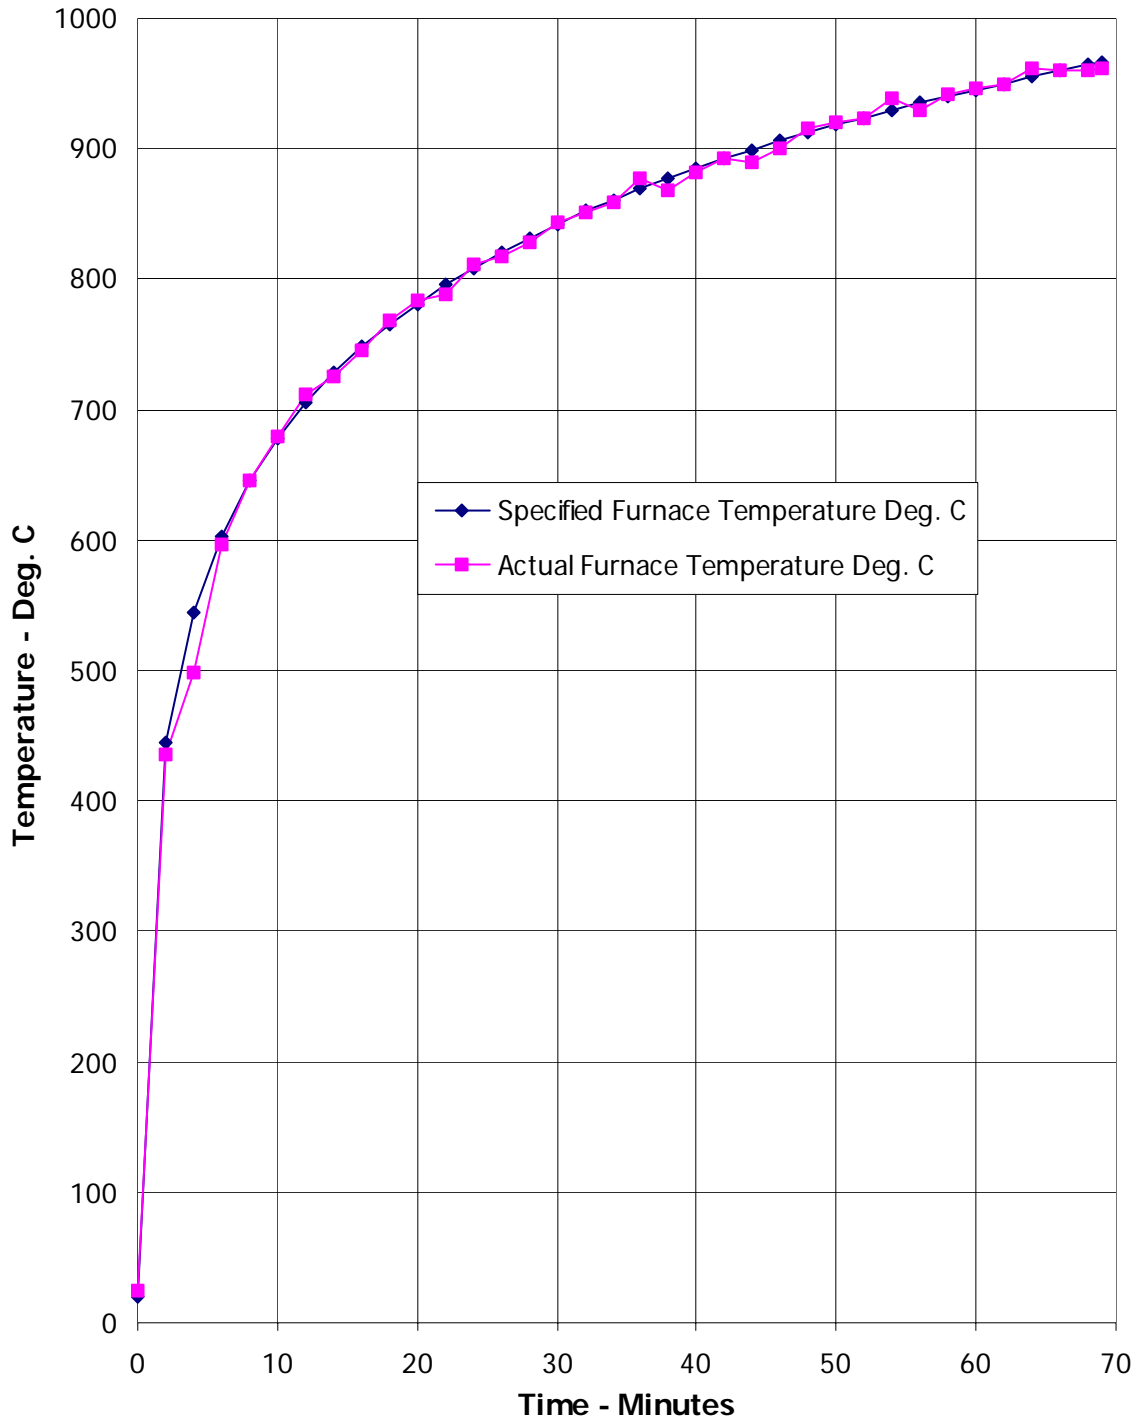
Graph Showing Mean Furnace Temperature, Together With The Temperature/Time Relationship Specified In The Standard

Time Mins	Specified Furnace Temperature Deg. C	Actual Furnace Temperature Deg. C
0	20	24
2	445	436
4	544	498
6	603	596
8	646	645
10	678	680
12	706	711
14	728	725
16	748	745
18	766	769
20	781	783
22	796	789
24	809	811
26	820	818
28	832	828
30	842	844
32	852	851
34	860	859
36	869	877
38	877	868
40	885	882
42	892	893
44	899	889
46	906	901
48	912	915
50	918	921
52	924	923
54	930	938
56	935	929
58	940	941
60	945	946
62	950	949
64	955	961
66	960	960
68	964	960
69	966	961

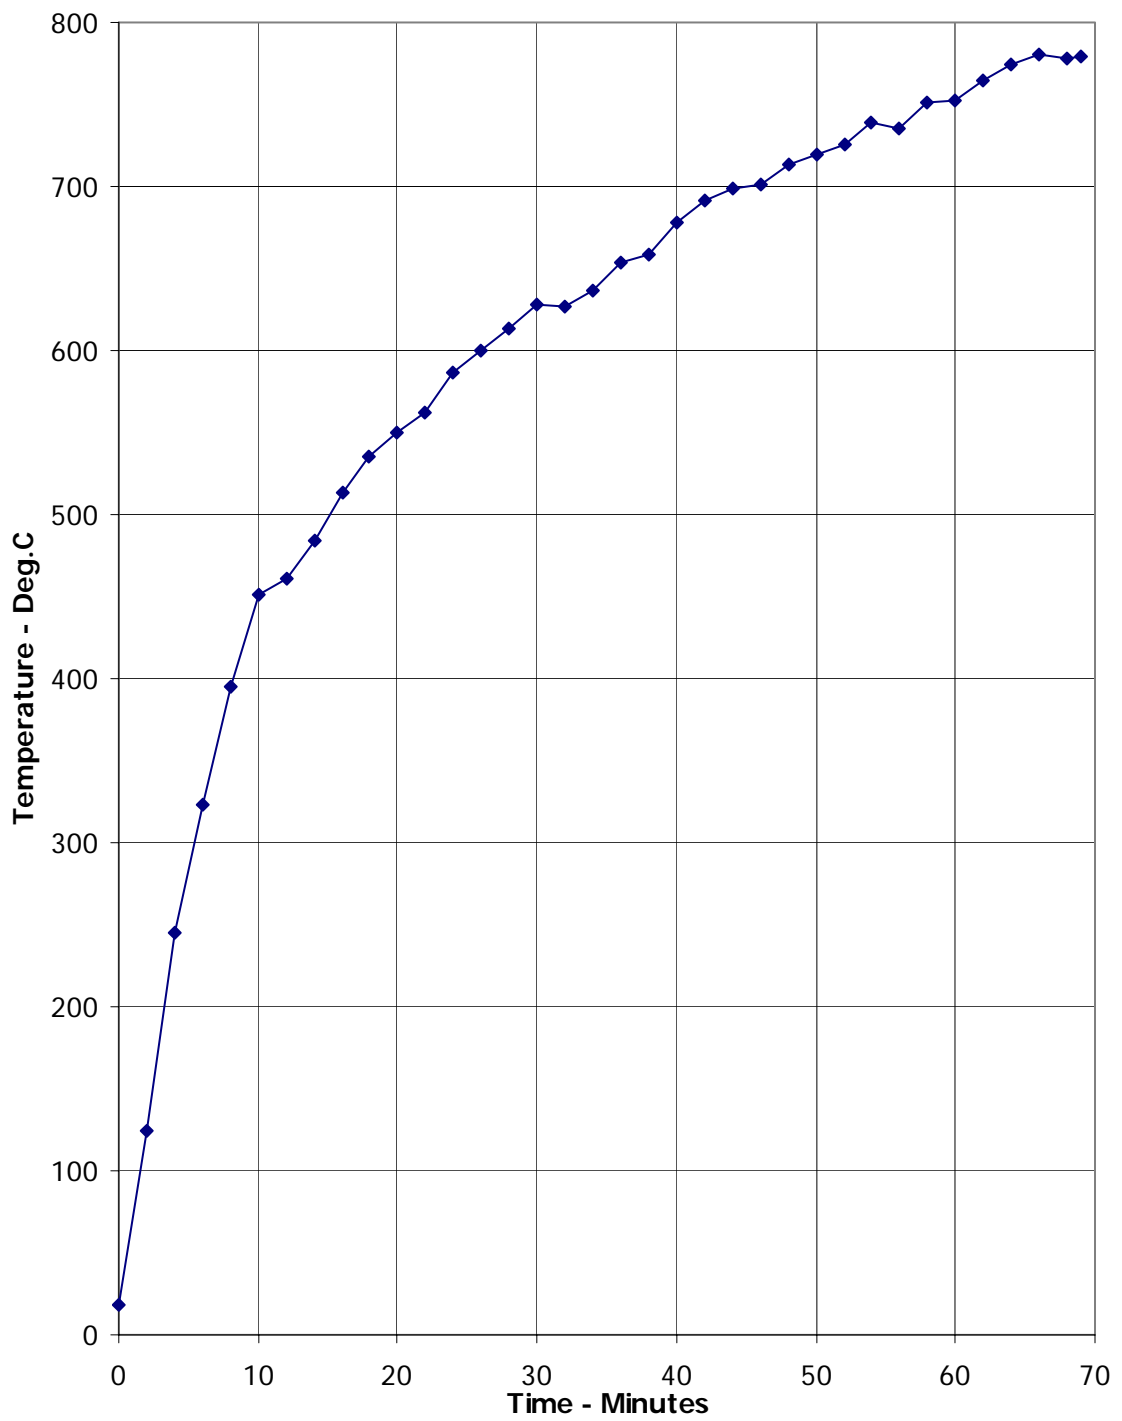
Graph Showing Mean Temperatures Recorded On The Unexposed Surface Of The Specimen

Time Mins	T/C Number 2 Deg. C	T/C Number 3 Deg. C	T/C Number 4 Deg. C	T/C Number 5 Deg. C	T/C Number 6 Deg. C	Mean Temperature Deg.C
0	18	18	18	19	18	18
2	91	153	150	110	120	125
4	*	259	231	*	*	245
6		333	314			324
8		395	395			395
10		434	469			452
12		443	478			461
14		464	505			485
16		492	535			514
18		511	560			536
20		527	574			551
22		536	588			562
24		560	613			587
26		575	625			600
28		593	634			614
30		611	646			629
32		627	*			627
34		637				637
36		654				654
38		659				659
40		678				678
42		692				692
44		699				699
46		701				701
48		714				714
50		720				720
52		726				726
54		739				739
56		735				735
58		751				751
60		753				753
62		765				765
64		774				774
66		781				781
68		778				778
69		779				779
